NDI No. PA 00482

KENNAMETAL RESERVOIR DAM

KENNAMETAL INC.

PHASE I INSPECTION REPORT NATIONAL DAM INSPECTION PROGRAM

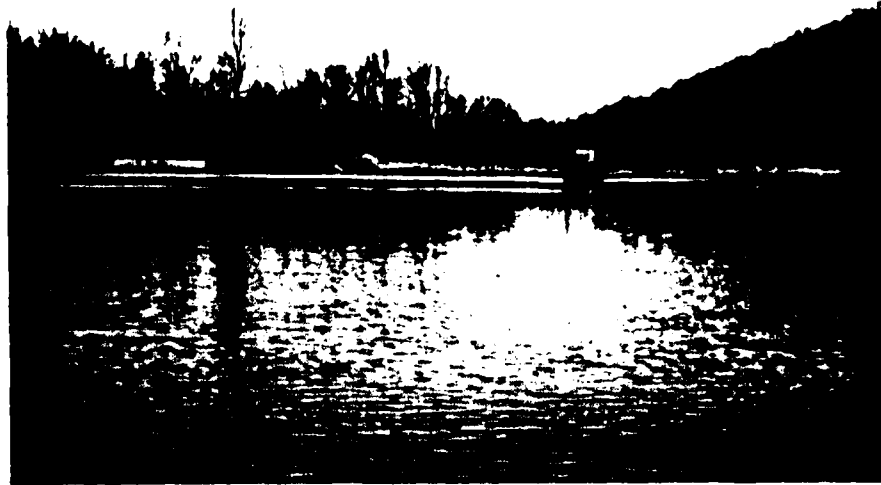
PHOTO 1. EMBANKMENT CREST AND SPILLWAY

The crest had considerable barren area and some minor erosion was visible. Possible severe erosion was indicated by the difference in elevation between the crest and spillway training wall. No cracks were observed.

c. Visual Observations: On the date of the field reconnaissance, possible severe erosion of the crest was indicated by the difference in crest and spillway wall elevations. The spillway, weir and training walls were in good condition.
